SMALL CHANGE

PART II “Plasticine Numismatics” by Jon Saxton

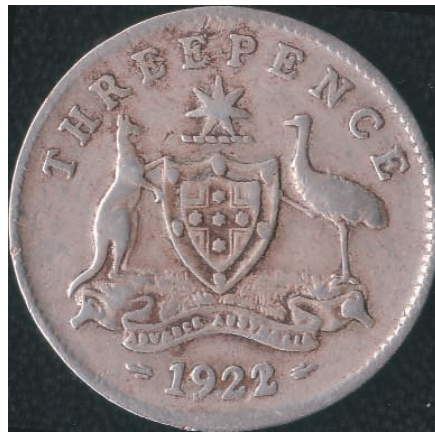
Figure 1: A 1922/1 overdate threepence. Fewer than 1000 of these exist.

In last month's article I presented a summary of my research into the small silver coinage of Australia. At the end of the article I promised that I would discuss the small number of 1922 threepences which appear to be overdates of a 1921 threepence (fig. 1). That these were indeed overdates was accepted without question until the release of the Royal Australian Mint's sixth annual report for 1969-70. The RAM report said that mint officials had long held the belief that the apparent overdate was the result of “spalling”, a form of die fracture caused by pressure. The relevant portion of the report is presented in the sidebar.

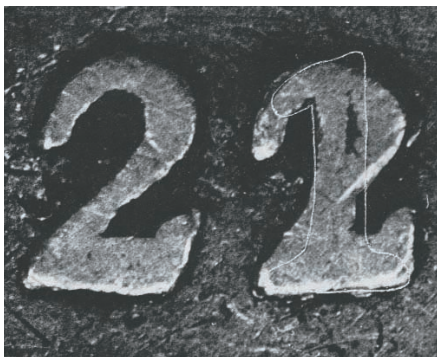
To support its case, the Royal Australian Mint made high-grade photographs of 1921, 1922 and 1922/1 threepences and produced a composite photo of a 1922/1 threepence showing the outline of the 1 in the position it occupies on the 1921 coin. The composite photo is reproduced in figure 2. From that picture it appears that if the threepence is indeed an overdate then we should expect to see the top of the 1 poking out of the top of the 2. We do not see such a protrusion on the actual coins and its absence would seem to lend weight to the RAM's case.

Figure 2: Composite photograph produced by the Royal Australian Mint to support its claim that the 1922/1 threepence was the result of a die fault.

In its investigation in the Mint's laboratory photographs of good 1921 and 1922 coins were enlarged and the negatives were superimposed; this revealed many discrepancies which failed to support the concept of an 'over-date'. Photographs of the figures of an 'over-dated' coin and the result of the superimposition are reproduced in the illustration.

Whether hand-punched or over-hubbed, support for the overdate hypothesis comes from the Royal Australian Mint's own photographs of the coin. Referring to figure 2 one can see that the underlying 1 is thinner than that on the 1921 coin in exactly the way one would expect if a 2 were punched over a 1. The metal displaced by the 2-punch has to go somewhere and into the valley of the 1 is a logical and convenient place. Furthermore, the upper portion of the 1 flanked by two segments of the 2 are thinner than the lower portion with part of the 2 on just one side.

the RAM's picture shown earlier (fig. 2) and the resemblance will be apparent.

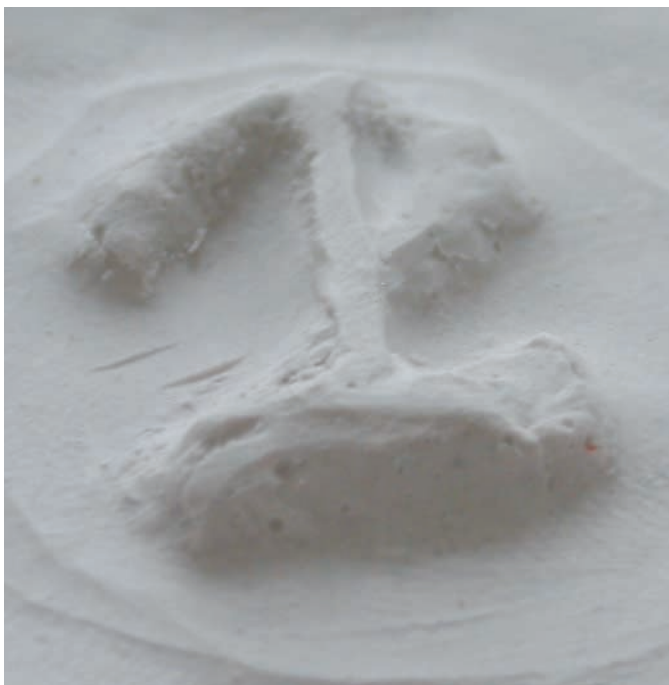
Figure 4: The end product of the plasticine experiment resembles the last digit of the date in figure 1.

Back home I made high-resolution mirror-image prints of a 1921 and a 1922 threepence, cut out the final digits from each and made pinprick outlines on two lumps of plasticine. I dug out the digits using a crude tool hammered from a piece of copper wire. Then with the aid of a couple of toilet roll tubes I made plaster casts of my plasticine dies, creating a 1-punch and a 2-punch. Once they were dry I used them to impress a plasticine tablet. On my third attempt I managed to get the 2 punch lined up to in such a way as to produce an "overdate die" showing a strong resemblance to the final digit(s) on the 1922/1 threepence. Finally I made a plaster cast of the result.

The tools and intermediate stages are shown in figure 3 and the final cast is shown in figure 4. Compare this with

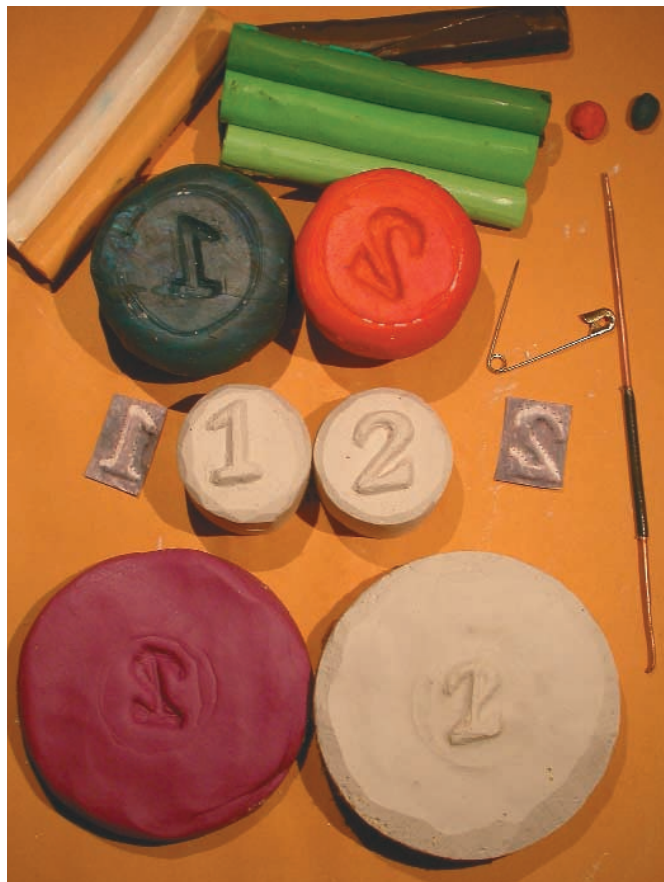
Figure 3: Plasticine numismatics. Note the paper pieces at each side. These were used to trace the outlines of the numbers on the plasticine "dies" at the top. The plaster "hubs" were used to press the composite "die" and the "coin" was made from the result.
